US Army Corps
of Engineers
New England Division
AUGUST 1987

DEFINITE PROJECT REPORT
PERLEY BROOK
FORT KENT, MAINE

EMERGENCY STREAMBANK PROTECTION

DEFINITE PROJECT REPORT

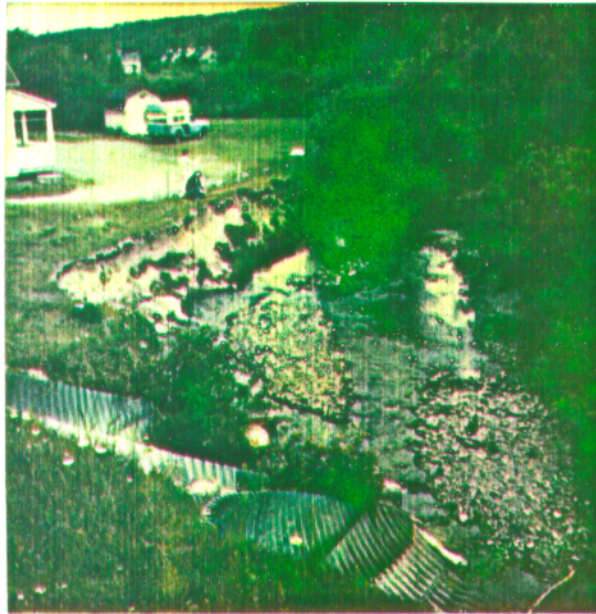
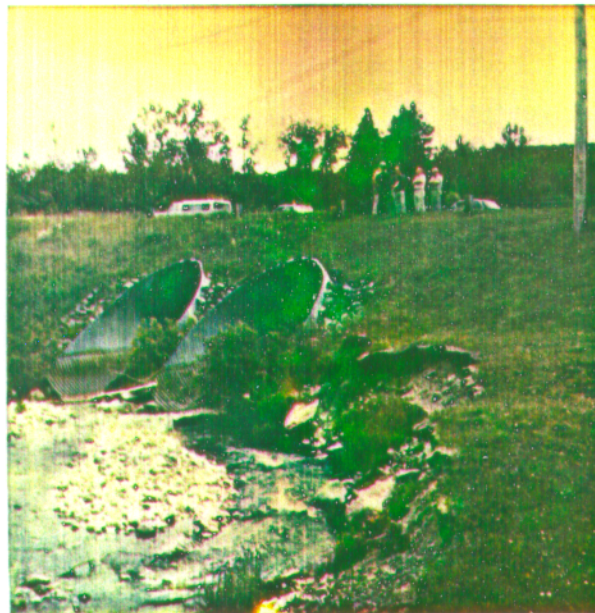
Figure 2

AREA PHOTOGRAPHS

Continuing erosion conditions caused by high stream stages, principally during the spring runoff periods, threaten destruction of the Route 161 highway embankment, adjacent to two 12'x 6" x 13'x10" corrugated metal pipe (CMP) culverts that carry Perley Brook under the roadway. The current erosion is immediately adjacent to a concrete highway boundary marker at the base of the embankment slope. The erosion area extends upstream about 100 linear feet (see photos - Figure 2).

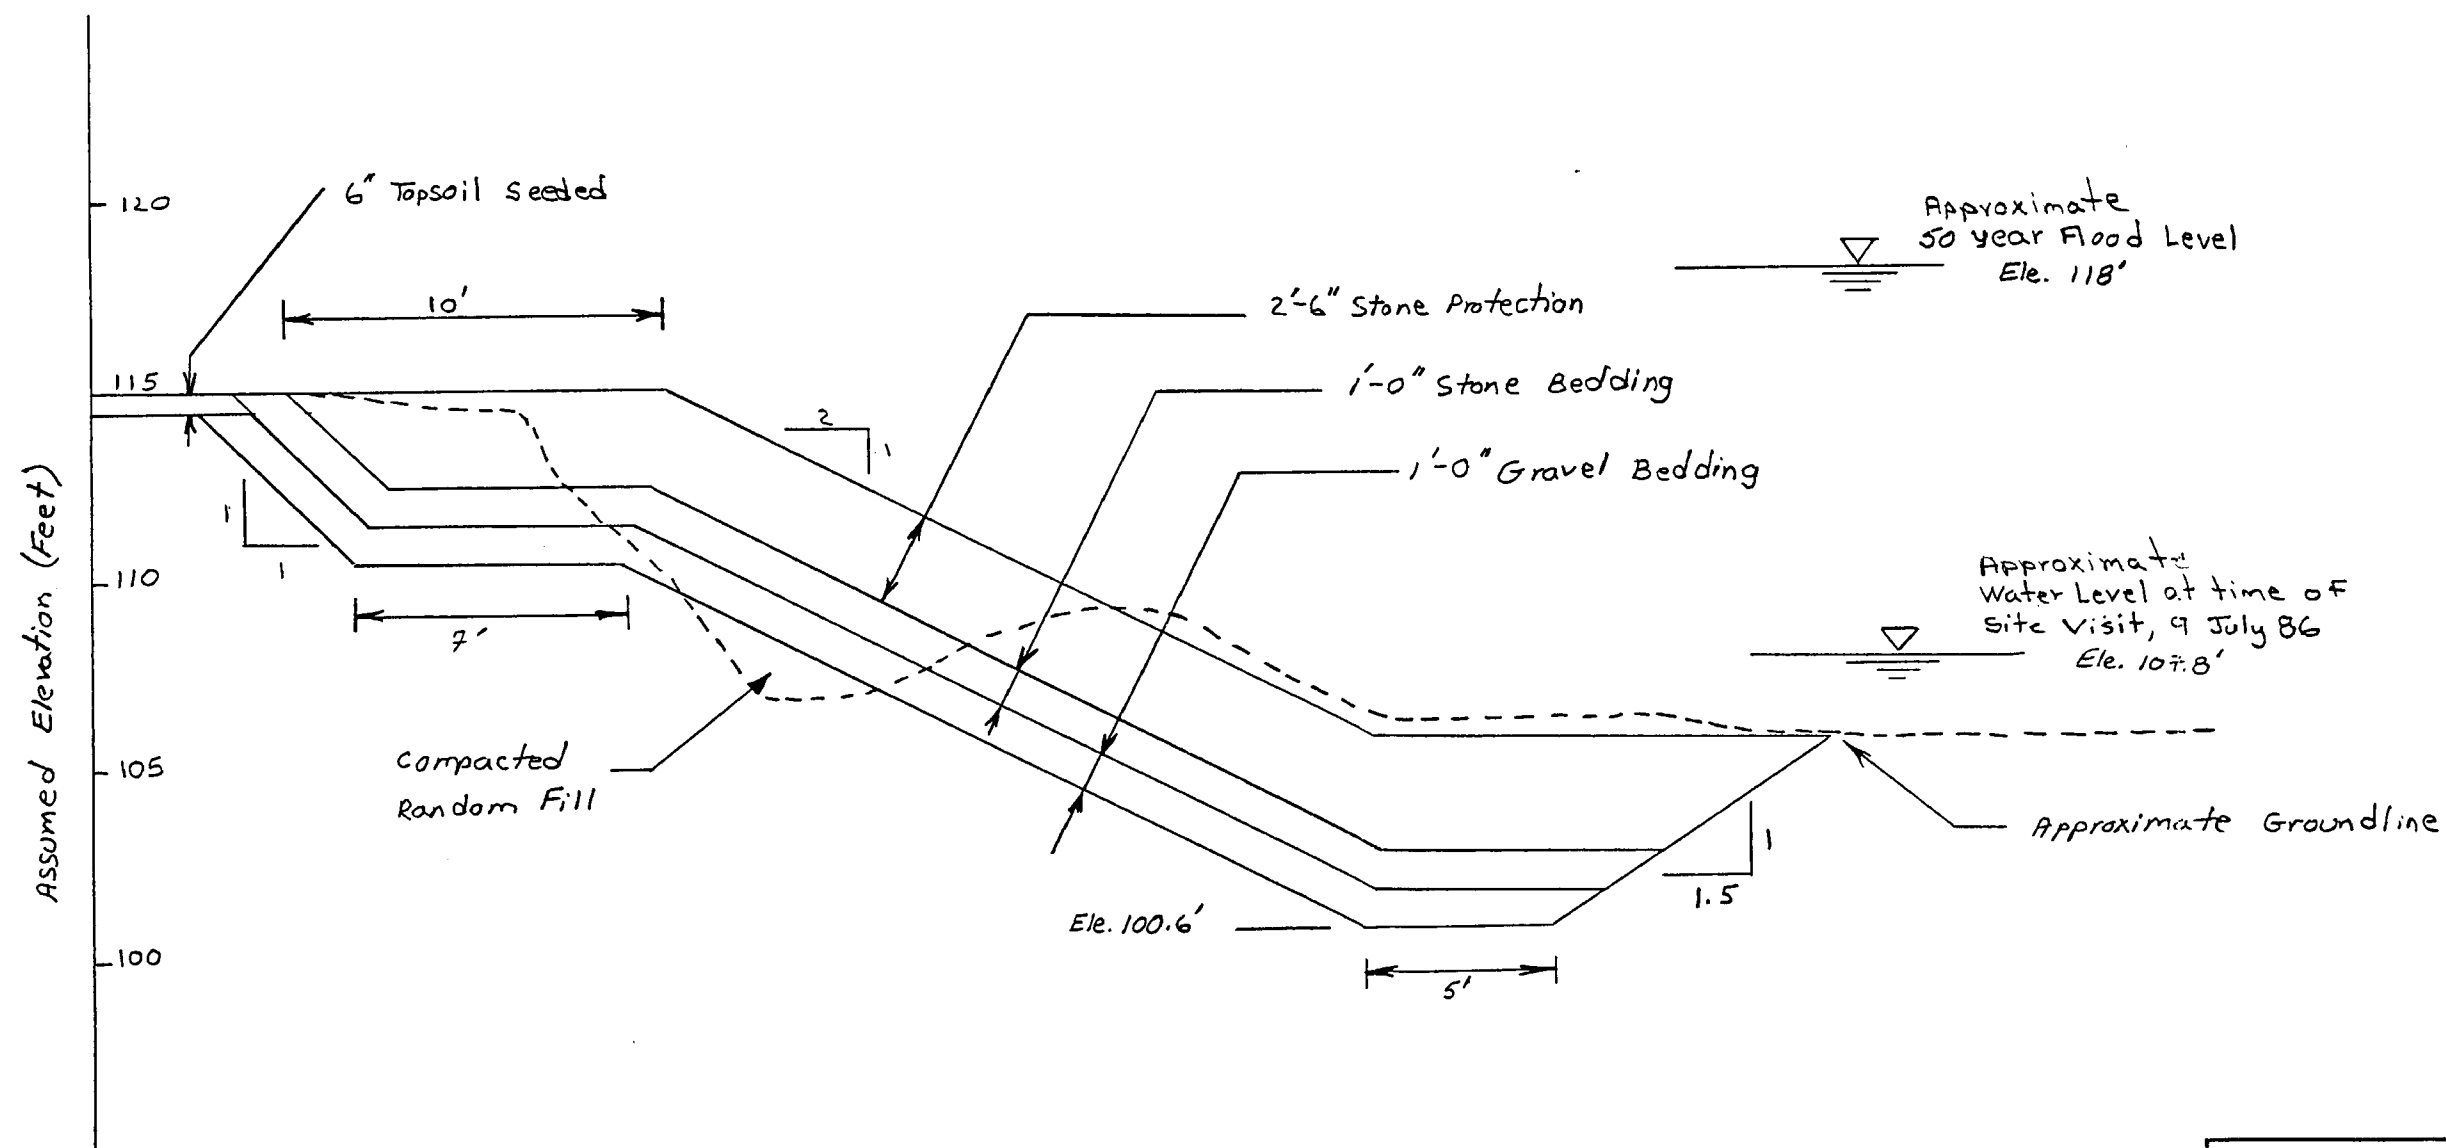
TYPICAL SECTION

EROSION CONTROL SECTION A-A

The selected plan calls for construction of a stone revetment along 100 linear feet of 6 to 10-foot high embankment adjacent to Route 161. The slope protection extends upstream along private property to prevent future erosion from extending around the protection and endangering an adjacent highway area. Stone protection was designed for the site based on the 50-year flood event. The D50 stone size needed to protect the bank from a flood of this magnitude is 1.1 feet. The slope protection would be placed on a 1 vertical to 2 horizontal slope. The stone protection would be 2'-6" thick while the stone bedding and gravel bedding layers would be one-foot thick (see Figure 4 - Typical Cross Section).
